## **Kinetic Super-Resolution Long-Wave Infrared (KSR LWIR) Thermography Diagnostic for Building Envelopes**

Camp Lejeune, NC

August 2015

Final Report

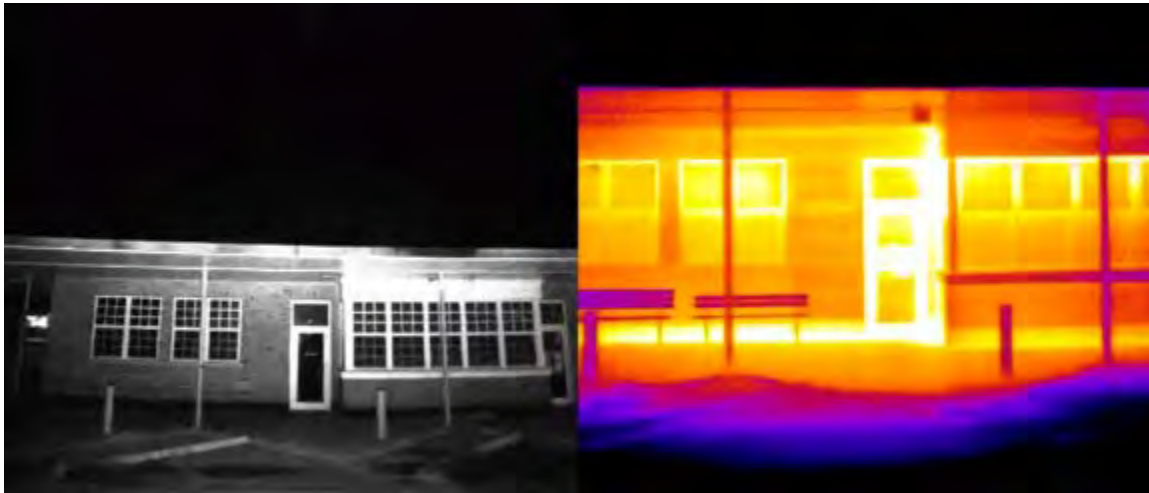
Figure D-81. NIR image (left) and thermal image (right) of Bldg 235, Camp Lejeune.

Bldg 235 has generally poor insulation in all of its walls (Figure D-81). This can be seen at timestamp 110:43, in addition to a highly emissive door frame indicating air leakage.

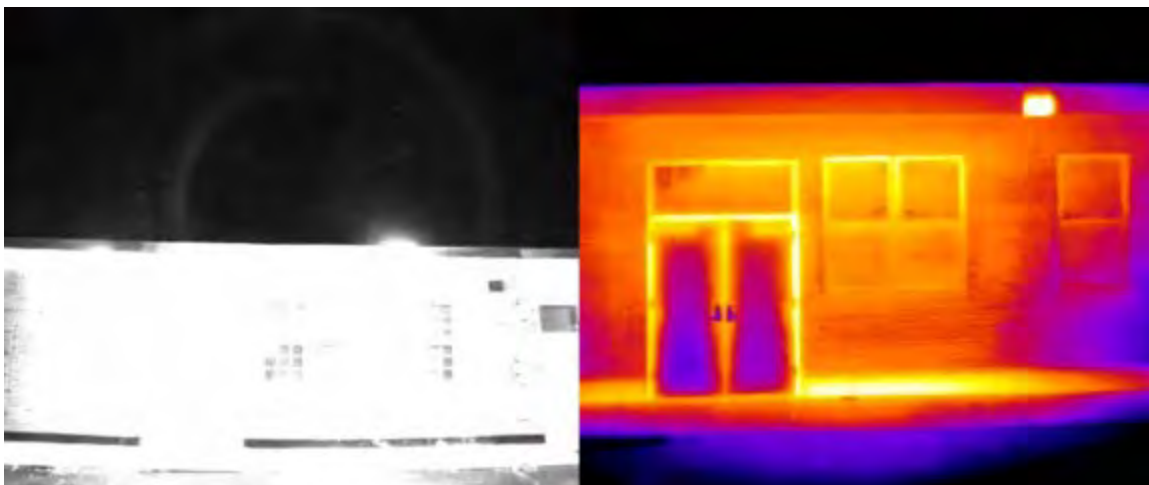
The wall at timestamp 110:48 is also quite emissive, as is the door frame near the left side of the image (Figure D-82).

Figure D-82. NIR image (left) and thermal image (right) of Bldg 235, Camp Lejeune. The wall and door frame are also quite emissive.

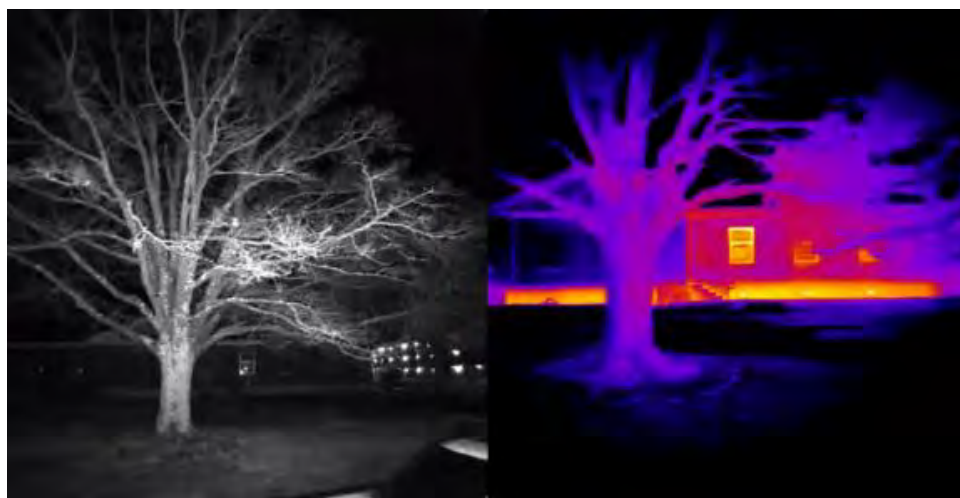
Figure D-86. NIR image (left) and thermal image (right) of Bldg 322, Camp Lejeune.

The exposed foundation visible at timestamp 312:50 is notably emissive, as is the window frame near the center of the image (Figure D-86).

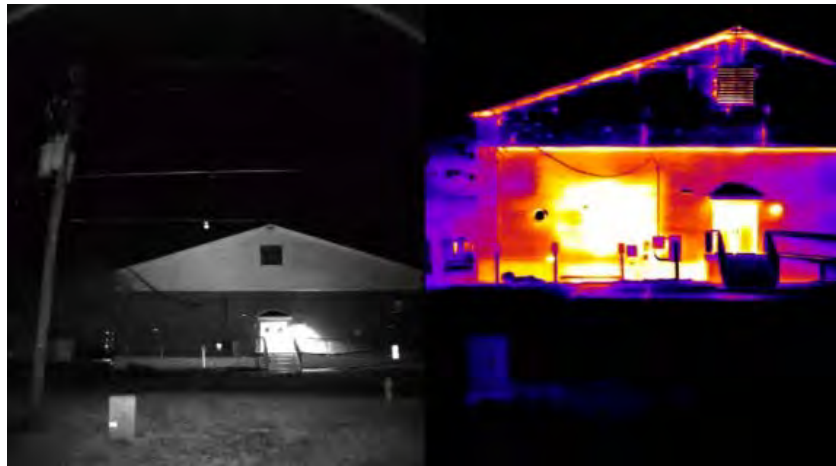
Figure D-91. NIR image (left) and thermal image (right) of Bldg 401, Camp Lejeune.

There is a large poorly insulated hot spot on the left side of the image at timestamp 354:09. The soffits at the top of the brick wall and at the roof-line are both quite poorly insulated (Figure D-91).

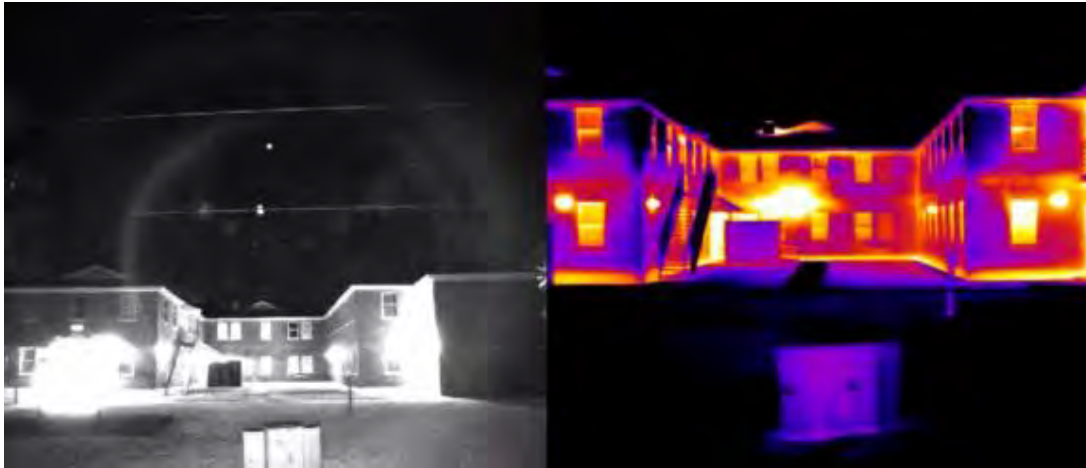
Figure D-95. NIR image (left) and thermal image (right) of Bldg 407, Camp Lejeune.

The walls of Bldg 407 at timestamp 354:25 are highly emissive, with hot spots on the right side of the image and in the back center (Figure D-95).

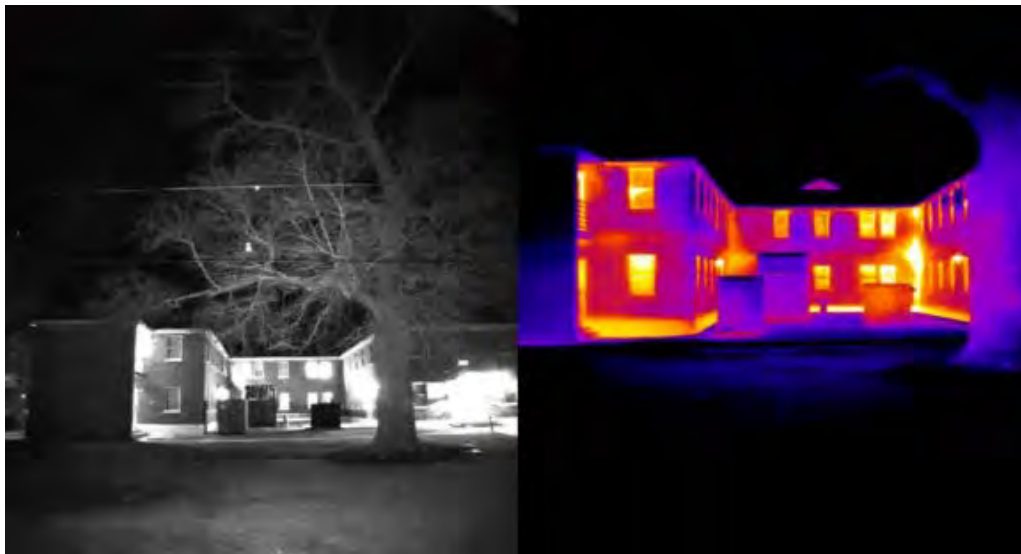
The wall in the left corner of the back of the image at timestamp 354:28 is notably hot, which indicates poor insulation (Figure D-96).

Figure D-96. NIR image (left) and thermal image (right) of Bldg 407, Camp Lejeune. The wall in the left and right rear corners is notably hot, which indicates poor insulation.

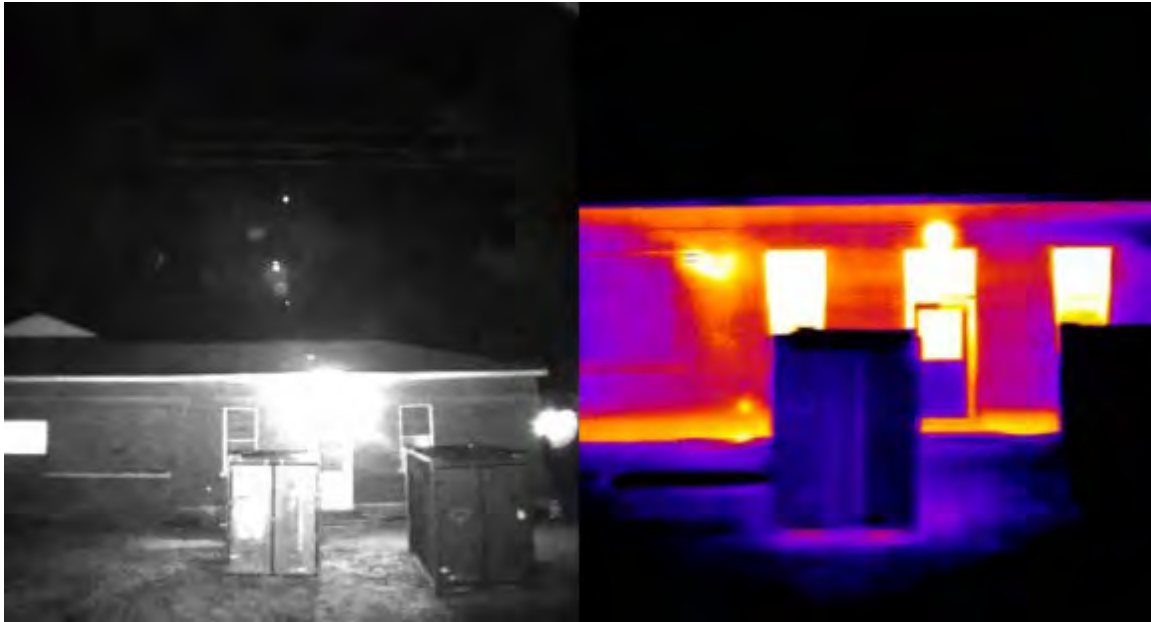
Figure D-100. NIR image (left) and thermal image (right) of Bldg 408, Camp Lejeune.

There is a large poorly insulated hot spot at timestamp 356:55 on the left side of the image. The door frame in the center of the image is also fairly leaky and would benefit from air sealing (Figure D-100).

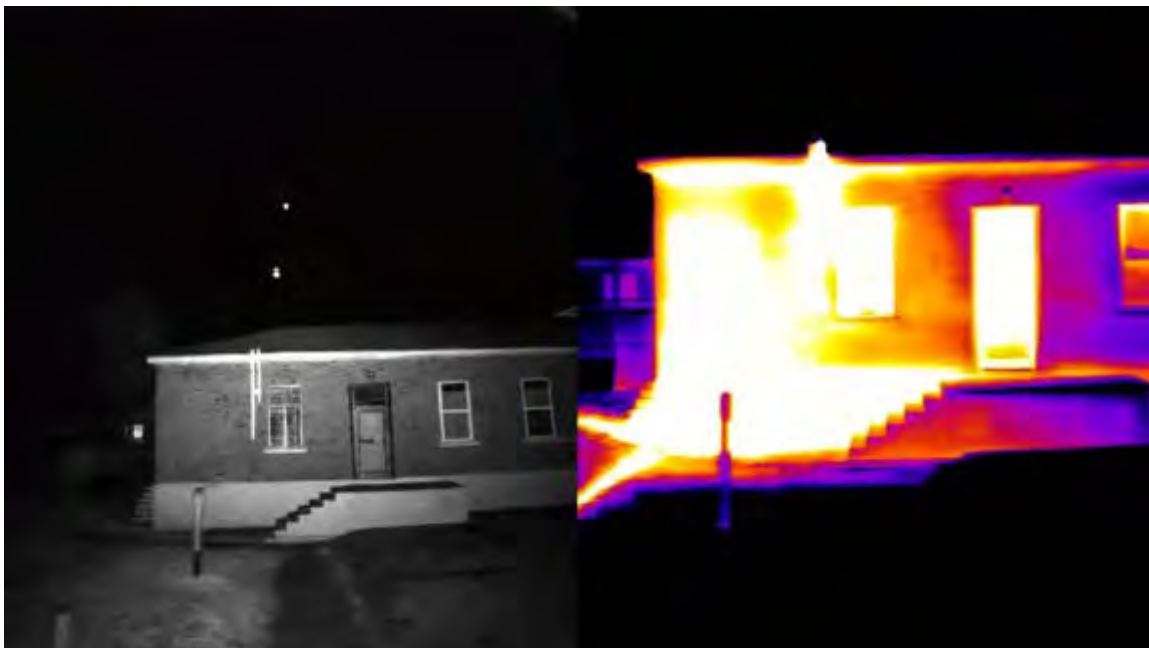
Figure D-105. NIR image (left) and thermal image (right) of Bldg 424, Camp Lejeune.

The walls of Bldg 424 appear poorly insulated, particularly the portion on the left side of the image shown at timestamp 356:22 (Figure D-105).

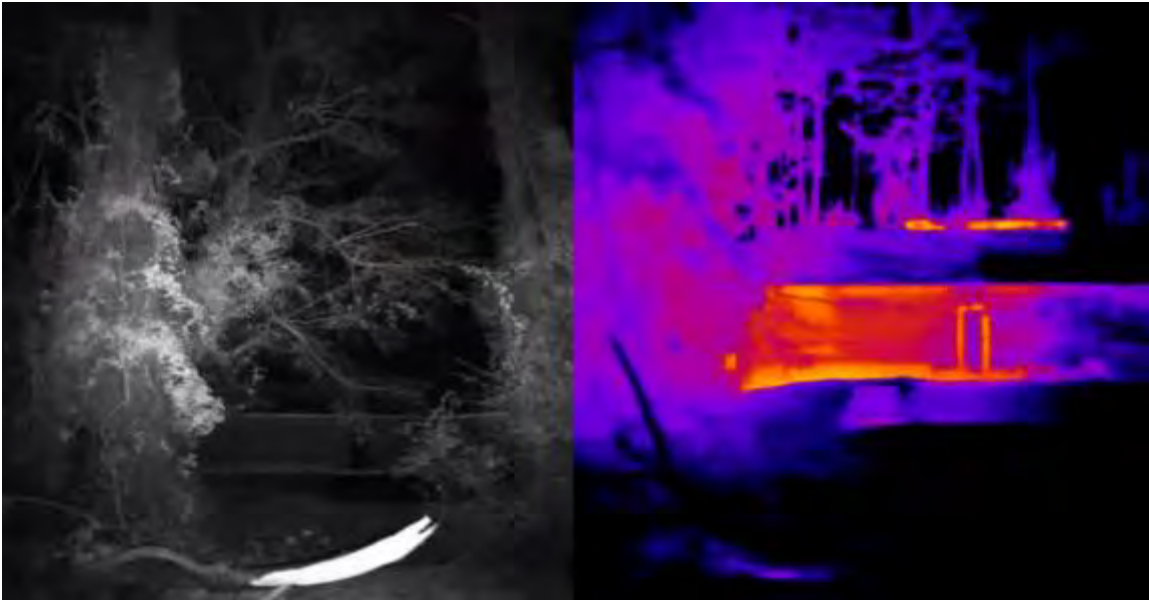
Figure D-109. NIR image (left) and thermal image (right) of Bldg 430, Camp Lejeune.

The walls of Bldg 430 are noticeably hot, as shown at timestamp 163:58 (Figure D-109). There is a hot spot in the wall on the left of the image, as well as around the door frame on the right side of the image.

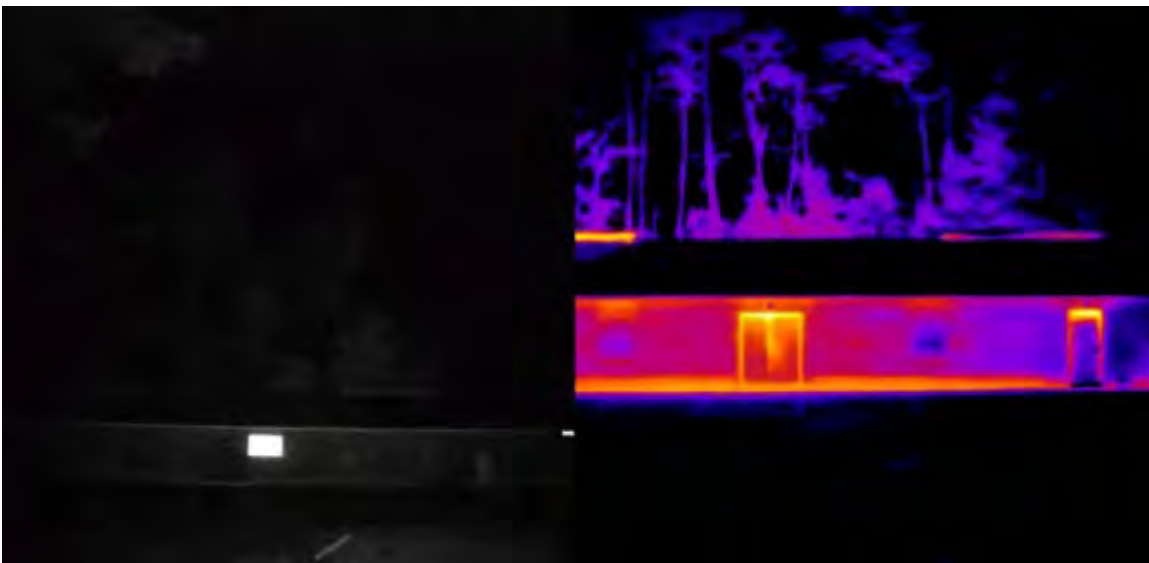
The door frame at the center of the image at timestamp 164:00 is fairly emissive (Figure D-110).

Figure D-110. NIR image (left) and thermal image (right) of Bldg 430, Camp Lejeune. The door frame at the center of the image is fairly emissive.

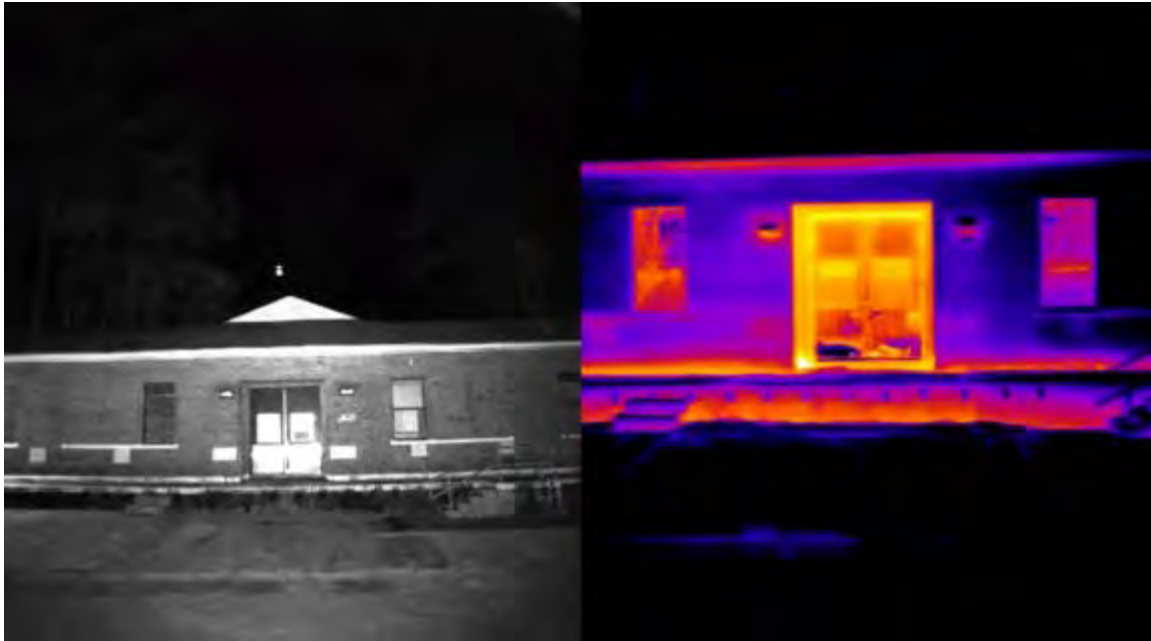
Figure D-114. NIR image (left) and thermal image (right) of Bldg 508, Camp Lejeune.

The door frame at timestamp 353:20 is quite emissive, which indicates potential air leaks (Figure D-114).

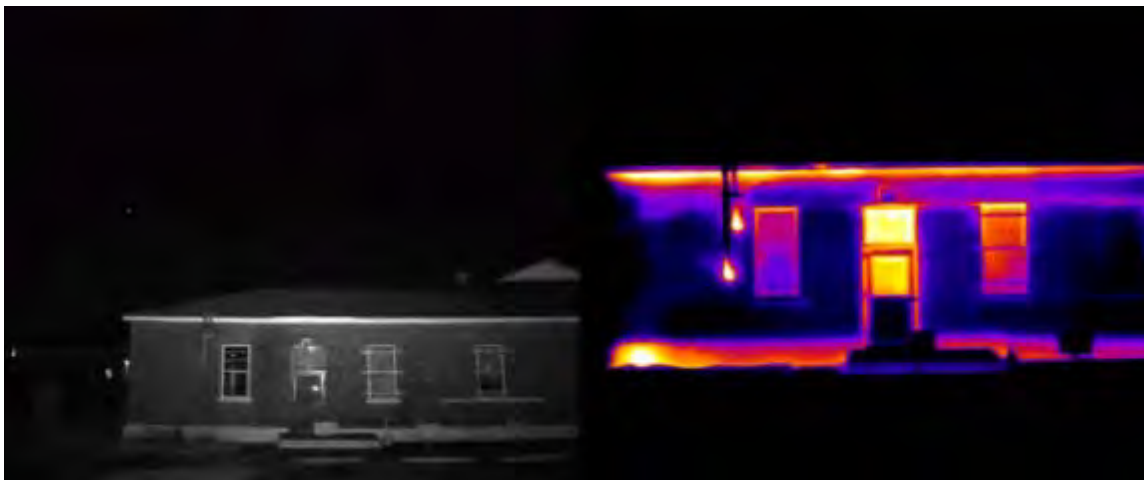
Figure D-119. NIR image (left) and thermal image (right) of Bldg 509, Camp Lejeune.

The soffits at timestamp 169:06 are noticeably emissive, and there is a hot strip to the right of the image above the window (Figure D-119).

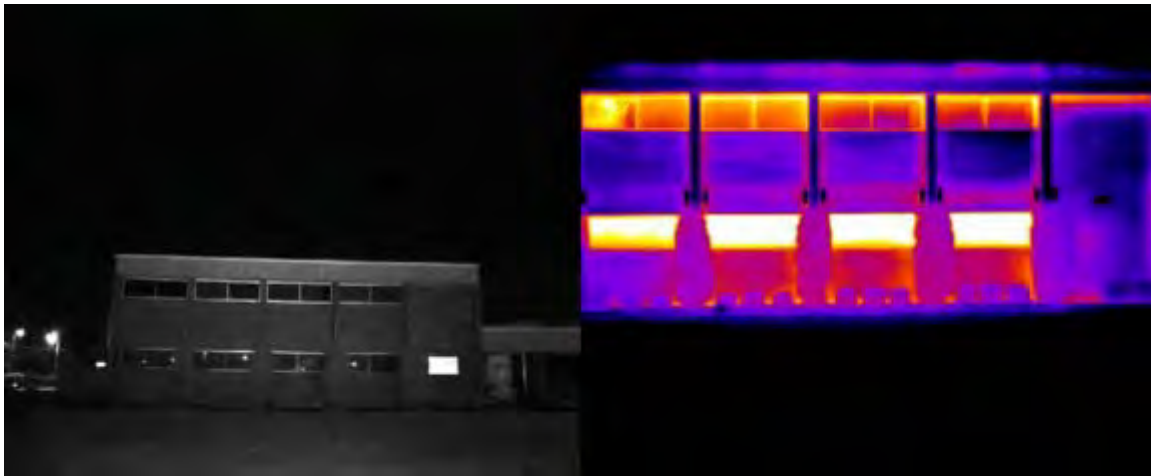
Figure D-123. NIR image (left) and thermal image (right) of Bldg 895, Camp Lejeune.

The windows of Bldg 895 are quite a bit more emissive than any other windows that were scanned on the base. They can be seen at timestamp 135:44 (Figure D-123).

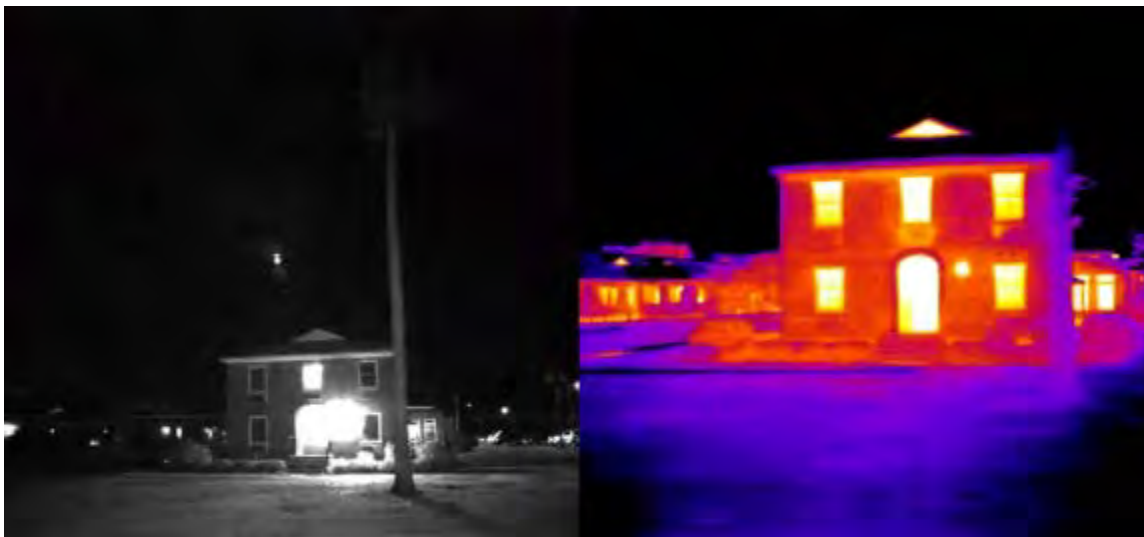
Figure D-127. NIR image (left) and thermal image (right) of Bldg 2603, Camp Lejeune.

The wall at timestamp 221:37 is poorly insulated, with a notable hot spot above the door frame (Figure D-127).

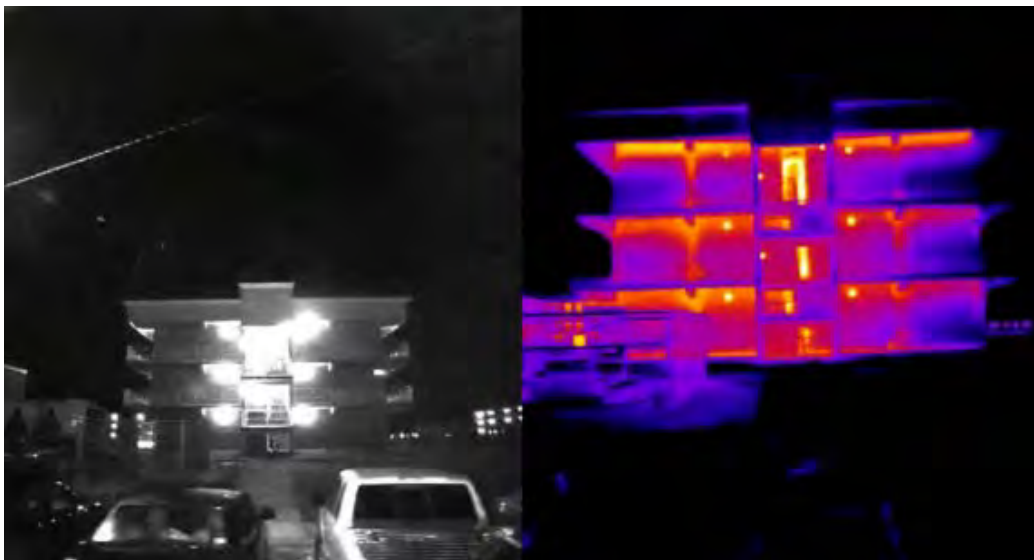
Figure D-131. NIR image (left) and thermal image (right) of Bldg HP285, Camp Lejeune.

The walls and door shown at timestamp 118:23 are notable emissive (Figure D-131).

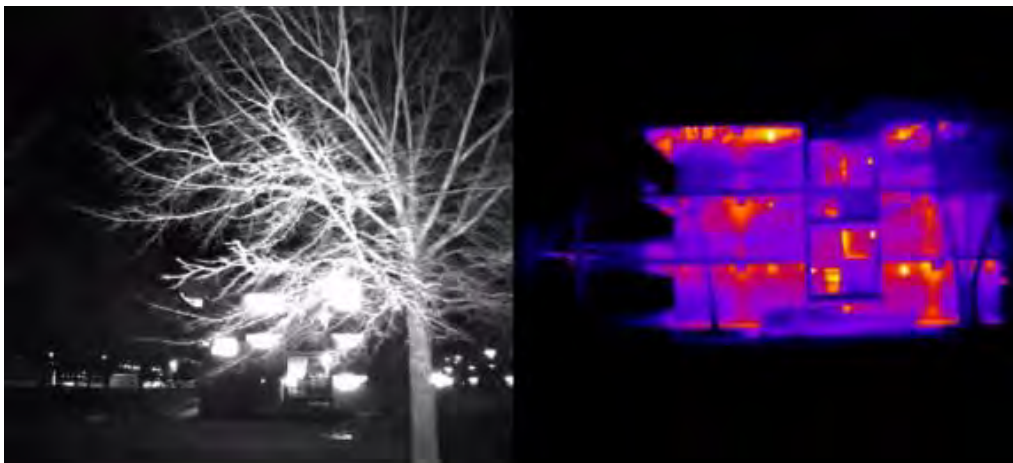
Figure D-135. NIR image (left) and thermal image (right) of Bldg HP507, Camp Lejeune.

The walls at timestamp 160:11 show a similar highly emissive pattern, with heat loss both at the top and down the middle of each wall (Figure D-135).
